YOUR INSPECTION REPORT

HeRo Home Inspection

911 What Happened Way
Accident, MD 21520

Monday, March 5, 2018

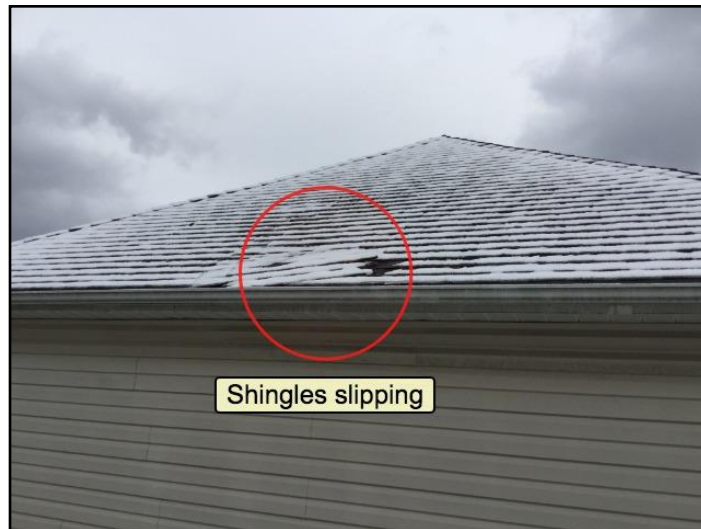
1. Condition: • [Missing, loose or torn](#)

Recommend immediate repair of roofing shingles to help prevent water intrusion.

Implication(s): Chance of water damage to contents, finishes and/or structure

Loose shingles

Task: Repair / Replace as required for proper function

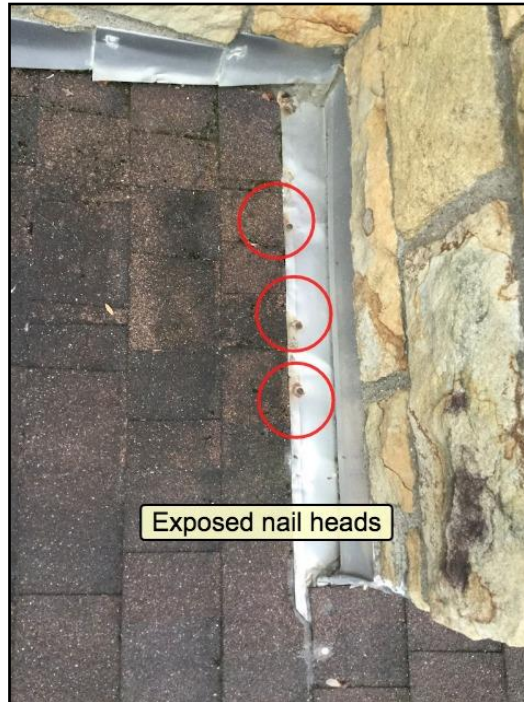
2. Condition: • [Exposed nails not sealed](#)

Implication(s): Chance of water damage to contents, finishes and/or structure

Exposed nails not sealed

Recommend caulking nail heads to help prevent water intrusion.

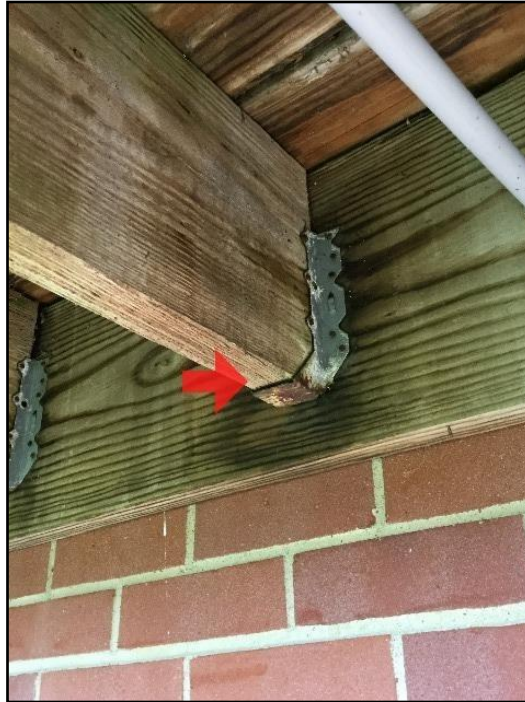
3. Condition: • [Fastener problems](#)

Rust forming on deck joist hangers throughout the bottom of rear deck. Recommend replacement and tighten all deck fasteners.

Fastener problems

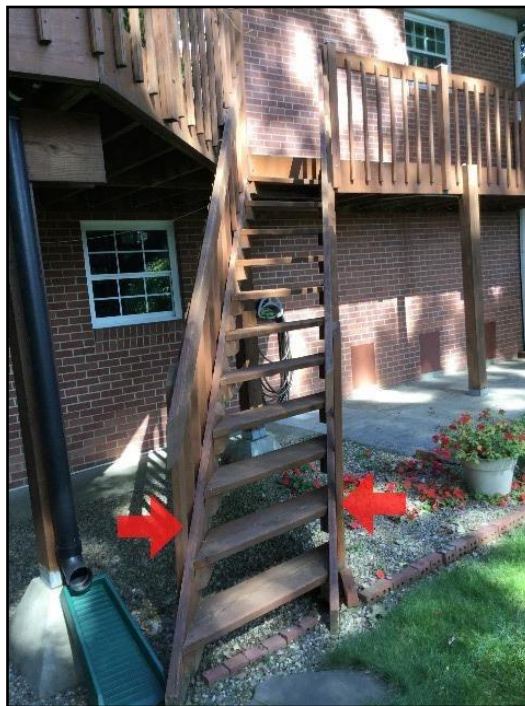
4. Condition: • [Tread widths too small or not uniform](#)

Stairs are substandard construction. The width is too narrow (22"). The riser is too high and needs to be enclosed to prevent tripping. This may be a nuisance and a fall hazard.

Implication(s): Trip or fall hazard

Tread widths too small or not uniform

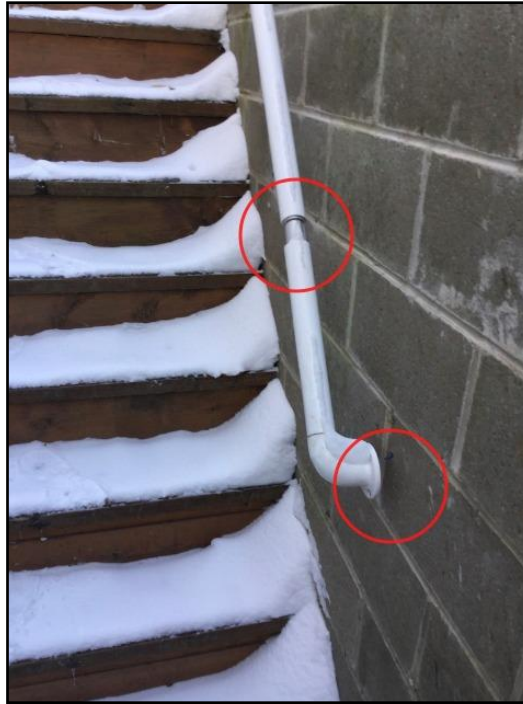
5. Condition: • [Loose](#)

Re-attach handrail to masonry wall as required for safety. This is a fall hazard.

Implication(s): Fall hazard

Loose handrail

Task: Recommend immediate repair for safety

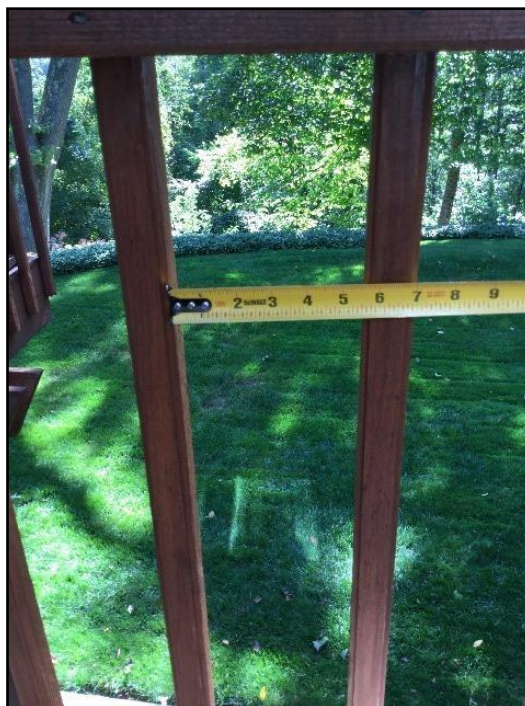
6. Condition: • [Spindles \(balusters\) too far apart](#)

Implication(s): Fall hazard

Spindles (balusters) too far apart

Task: Repair / Replace as required for proper function & safety

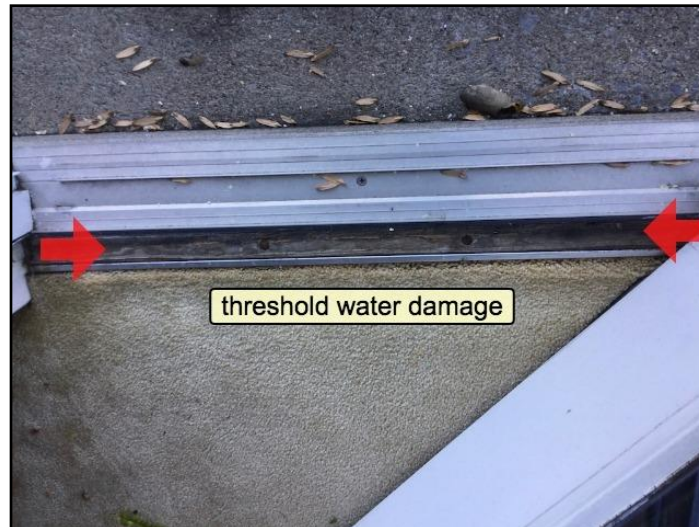
7. Condition: • [Door threshold missing, too low, not watertight](#)

Water damage noted at door threshold.

Implication(s): Chance of water damage to contents, finishes and/or structure

Door threshold rot

Task: Repair / Replace as required for proper function

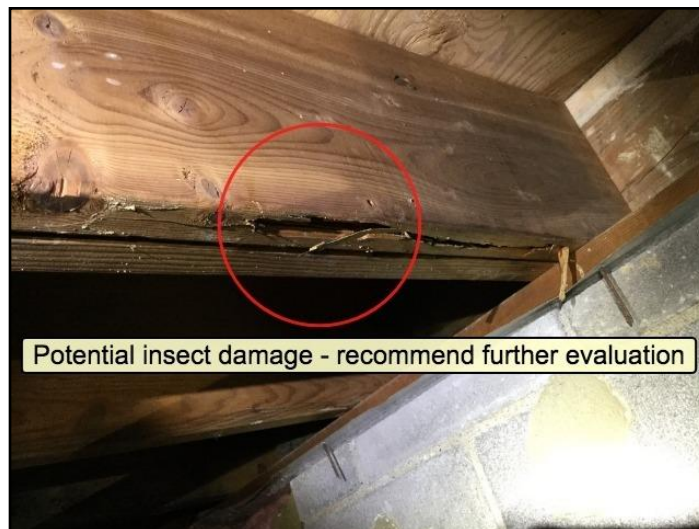
8. Condition: • Insect damage

Potential insect damage to floor joists under living room. Recommend further review.

Insect damage

Task: Further evaluation by an licensed exterminator. Repair as necessary.

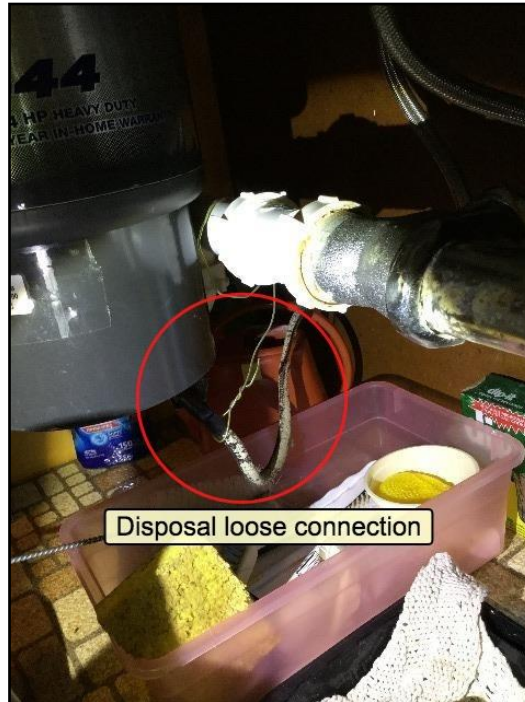
9. Condition: • [Loose connections](#)

Electrical strain relief connector missing at garbage disposal.

Implication(s): Electric shock | Fire hazard | Interruption of electrical service

Loose connections

Task: Repair / Replace as required for proper function & safety

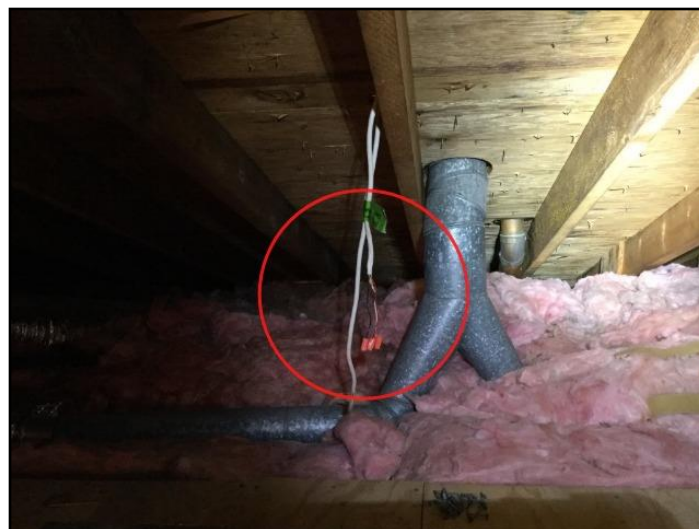
10. Condition: • [Abandoned wire](#)

Abandoned wire

Task: Repair / Replace as required for proper function & safety

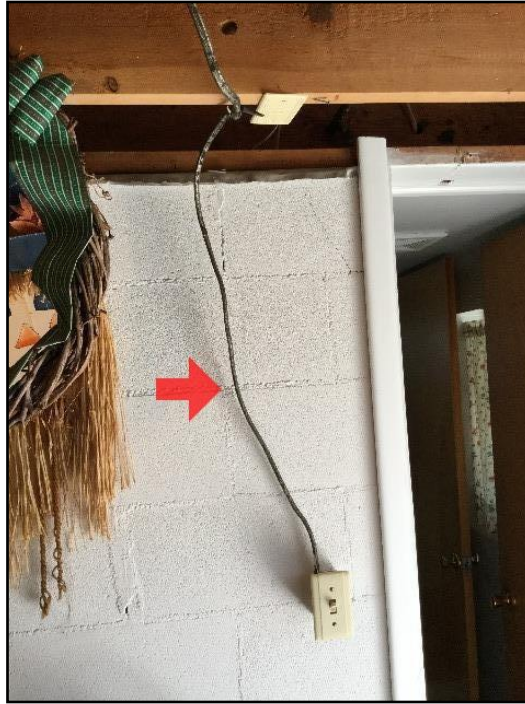
11. Condition: • [Exposed on walls or ceilings](#)

Exposed / loose on walls

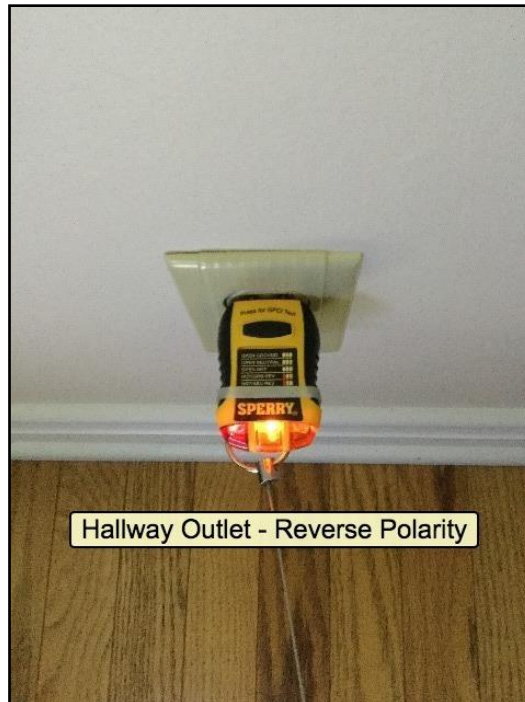
12. Condition: • [Reversed polarity](#)

Reversed polarity

Task: Repair / Correct for safety

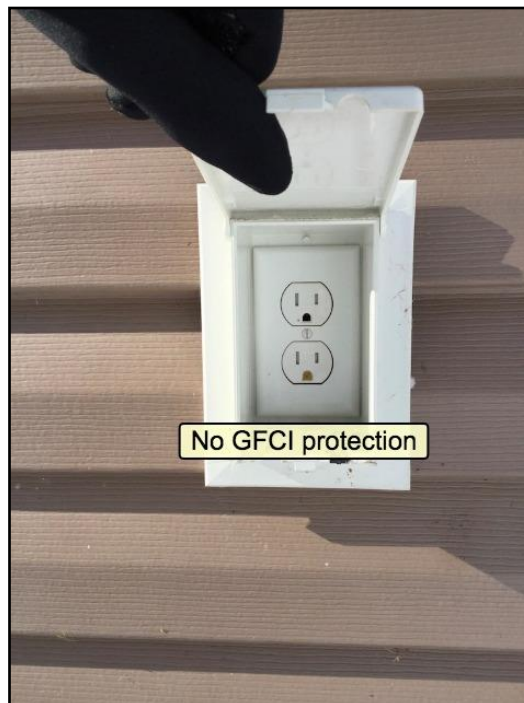
13. Condition: • [No GFCI/GFI \(Ground Fault Circuit Interrupter\)](#)

GFCI missing at exterior outlets

Task: Replace / Provide for safety

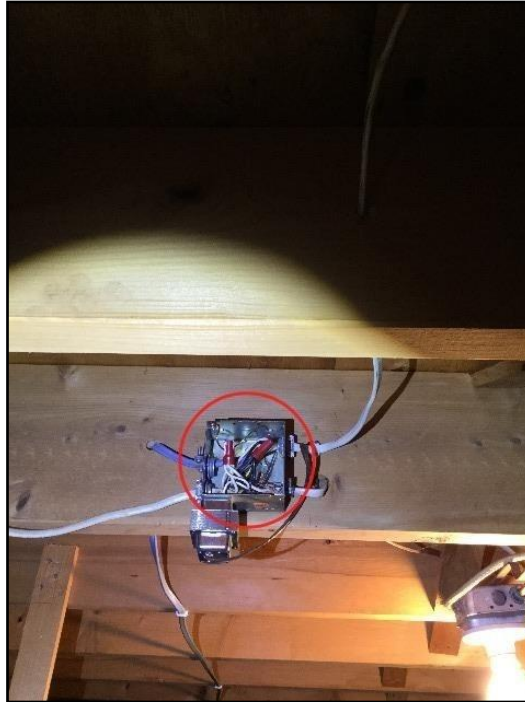
14. Condition: • For junction box is missing

Junction box cover missing.

Cover missing

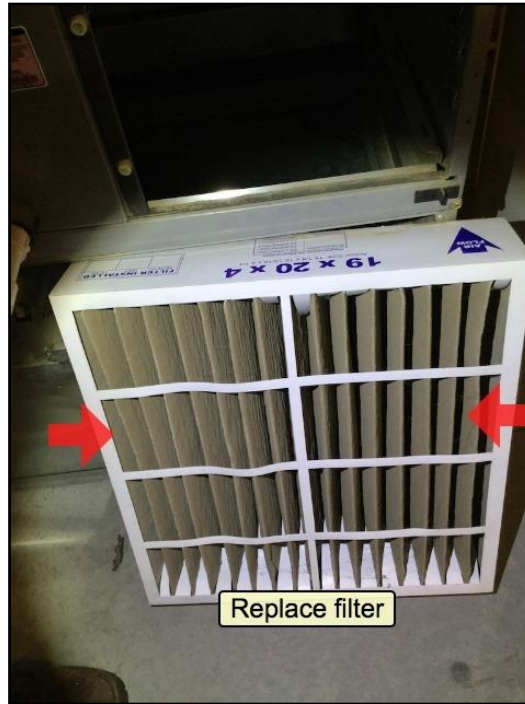
17. Condition: • [Dirty](#)

Dirty furnace filter

Task: Replace

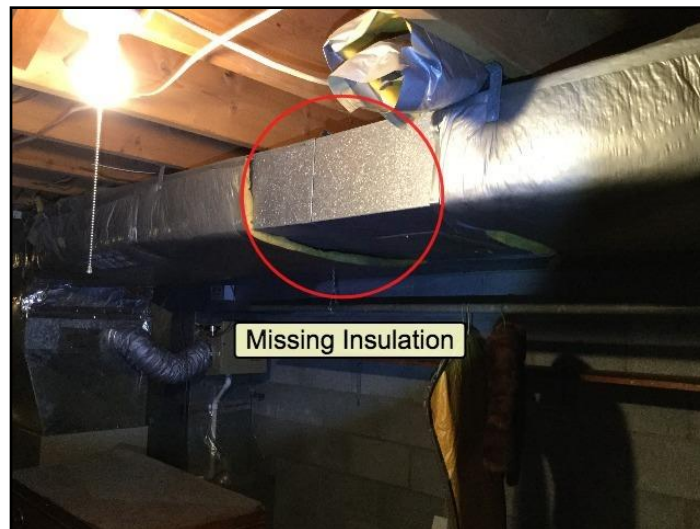
18. Condition: • [Insulation missing, damaged](#)

Missing insulation results in condensation creating excess moisture in the home and can damage interior finishes / furnishings.

Insulation missing, damaged

Task: Correct / Improve

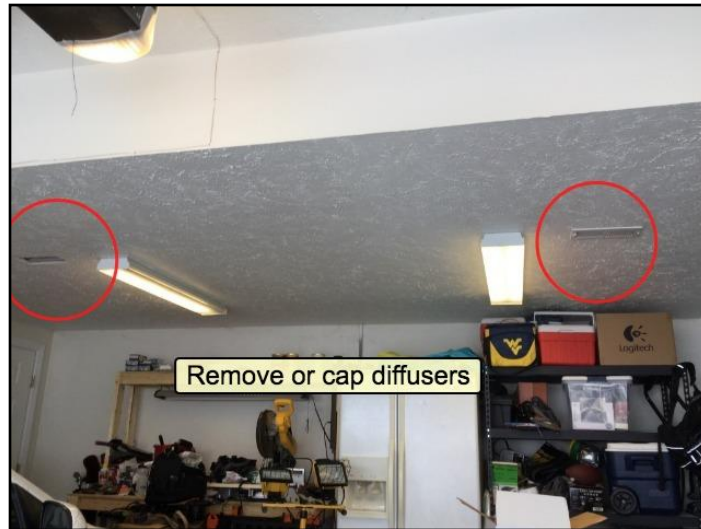
19. Condition: • [Registers or grilles in garage](#)

Implication(s): Hazardous combustion products entering home

Registers in garage

Task: Remove / cap for safety

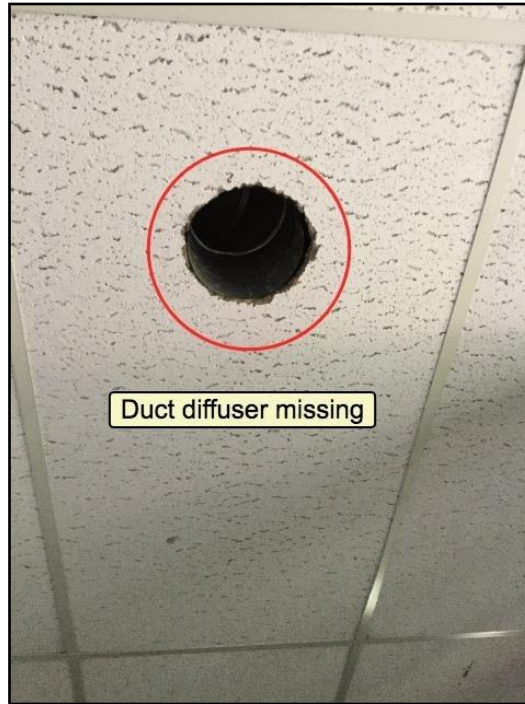
20. Condition: • Missing

Diffuser missing

Recommend all ductwork supply diffusers & return registers be installed for proper air flow & function.

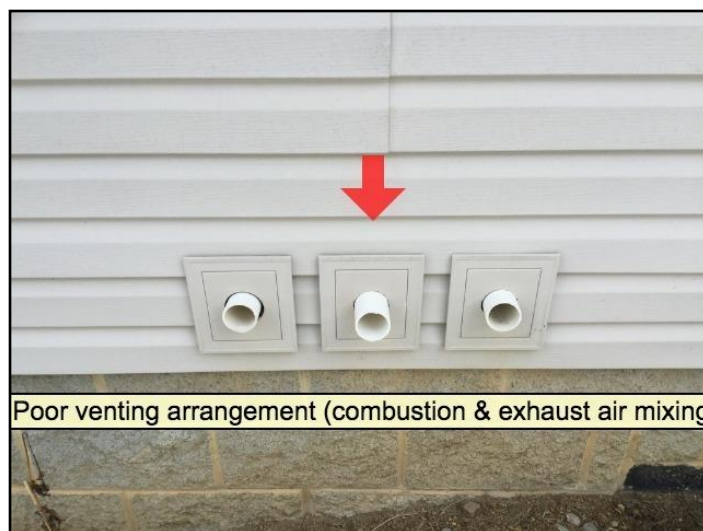
21. Condition: • [Poor vent location, arrangement](#)

Poor intake and exhaust venting arrangement. Industry standard recommends at least 12" separation between the combustion air intake and the exhaust. Piping arrangement should also be located 12" above snow accumulation level to help prevent snow enclosure. Refer to manufacturer's installation recommendations.

Implication(s): Equipment not operating properly | Equipment inoperative | Hazardous combustion products entering home

Poor vent location, arrangement

Task: Improve / Recommend further evaluation by a licensed HVAC contractor.

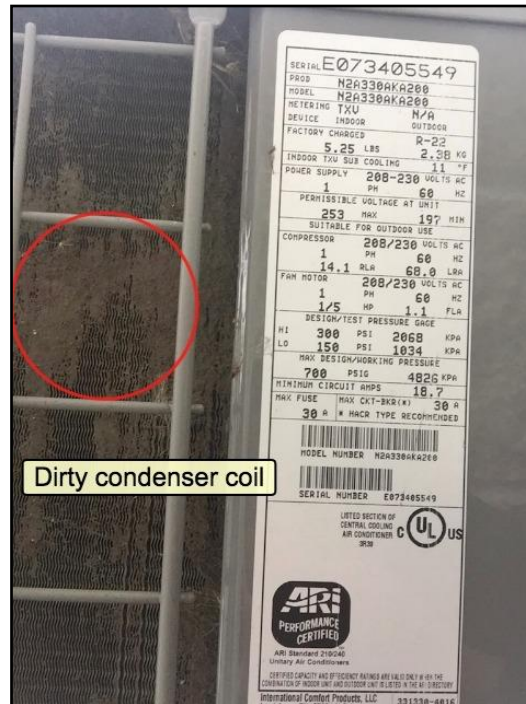
22. Condition: • [Dirty](#)

Dirty condenser coil

Task: Clean / Service

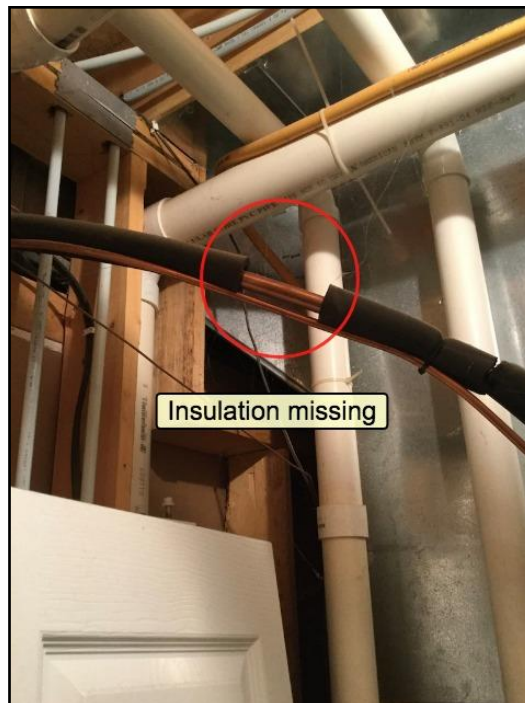
23. Condition: • [Insulation - missing](#)

Insulation - missing

Repair insulation to help with condensation and cooling efficiency.

Task: Repair / Improve

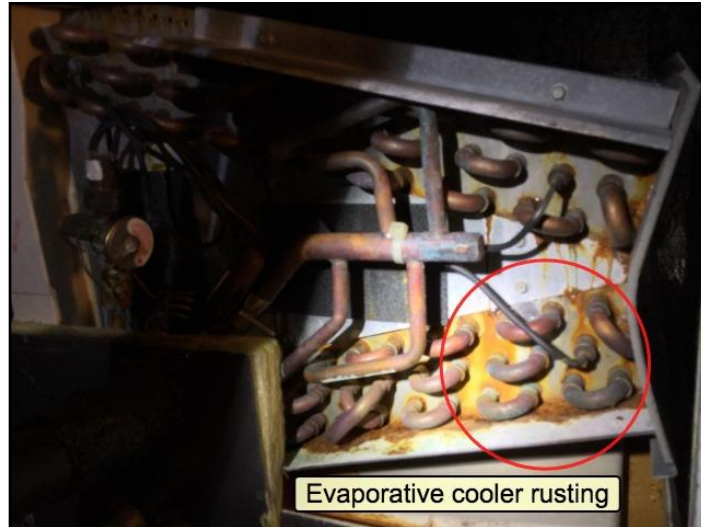
24. Condition: • Rust

Rust forming on AC coil.

Implication(s): Damage to equipment

Rust forming

Task: Further evaluation and service by a licensed HVAC contractor

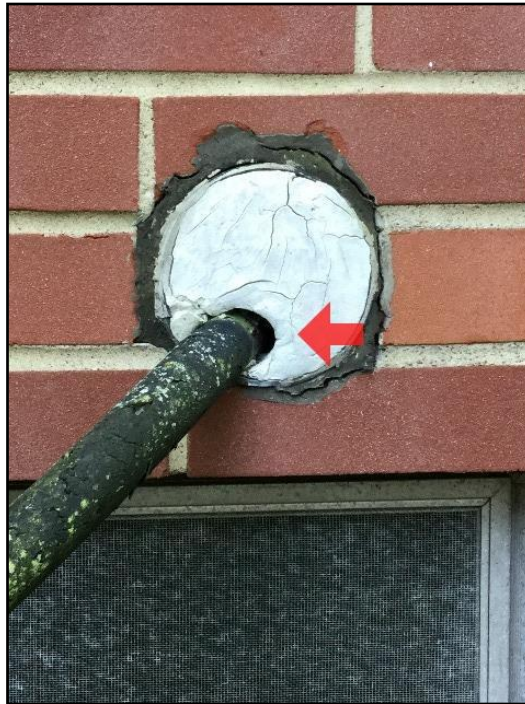
25. Condition: • [Poor seal at building](#)

Poor seal at building

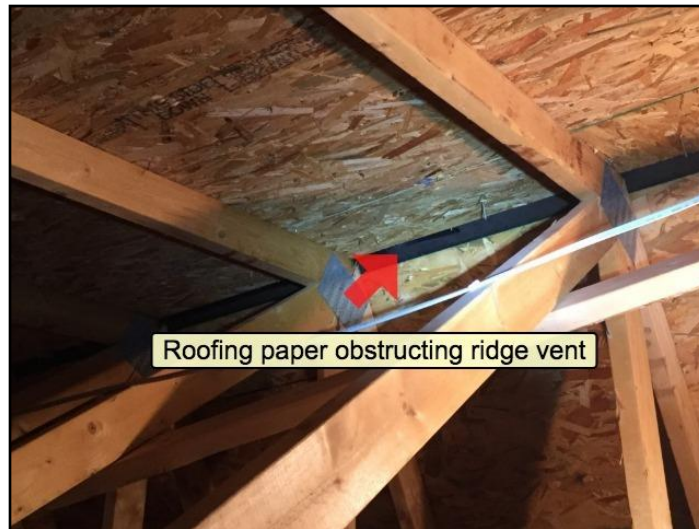
26. Condition: • [Obstructed](#)

Implication(s): Chance of condensation damage to finishes and/or structure

Obstructed ridge vent

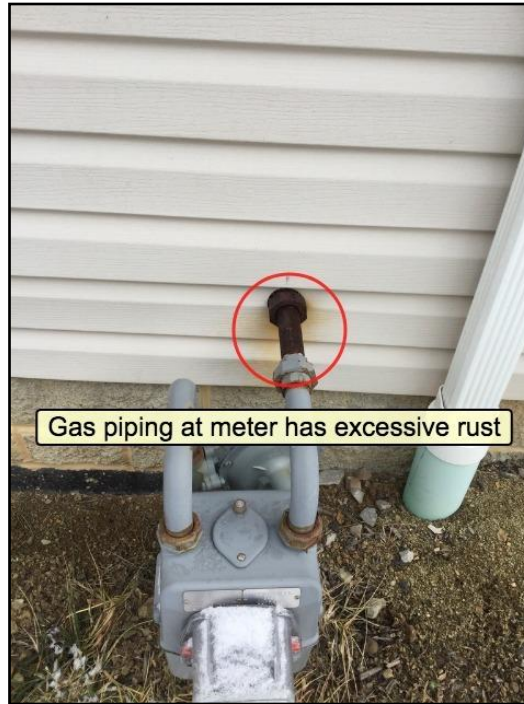
27. Condition: • [Rust](#)

Rust

Task: Improve

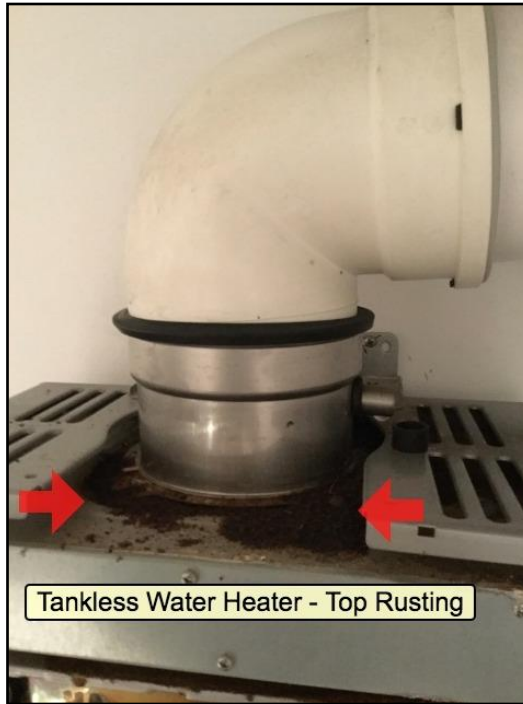
28. Condition: • [Rust, dirty, obstructed](#)

Combustion products not venting properly and creating rust on top of tankless water heater. Further review and evaluation.

Implication(s): Equipment not operating properly | Hazardous combustion products entering home

Water heater - rust

Task: Further evaluation by a licensed plumbing contractor

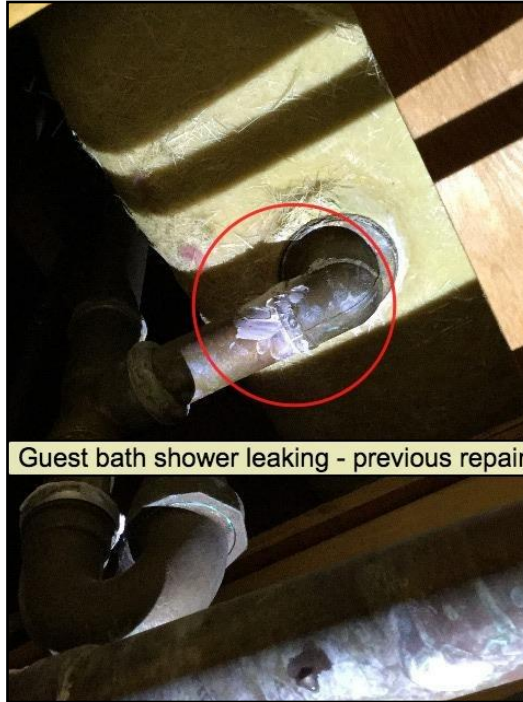
29. Condition: • [Leak](#)

Leak

Task: Repair / Replace as required for proper function

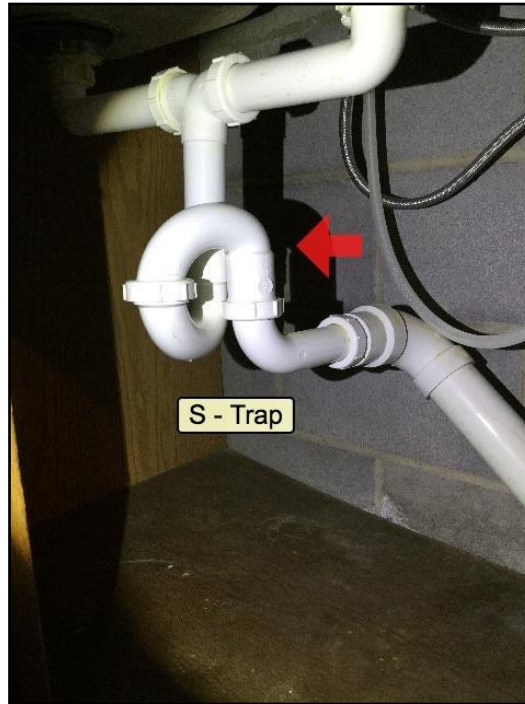
30. Condition: • "S" shaped trap allows siphoning of water out of the trap and permits sewer gases to enter home. Recommend replacing with a "P" trap for proper function.

Trap - Wrong type

Task: Repair / Replace as required for proper function

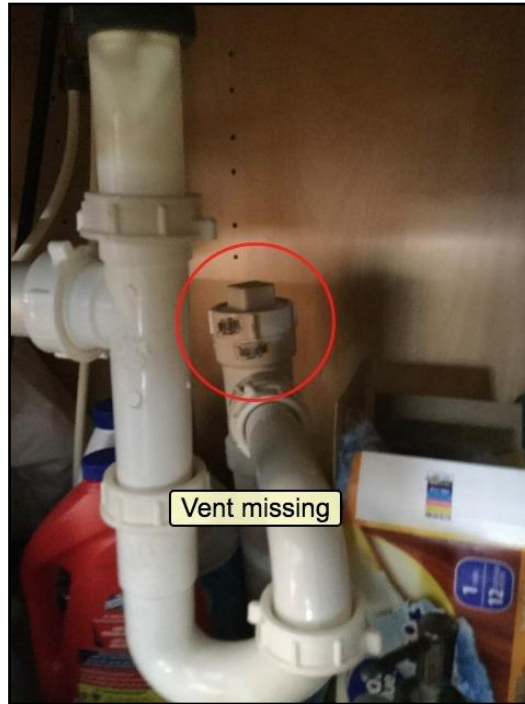
31. Condition: • [Poor vent pipe arrangements](#)

Poor venting

Recommend adding an AAV (automatic air vent) to improve kitchen sink venting.

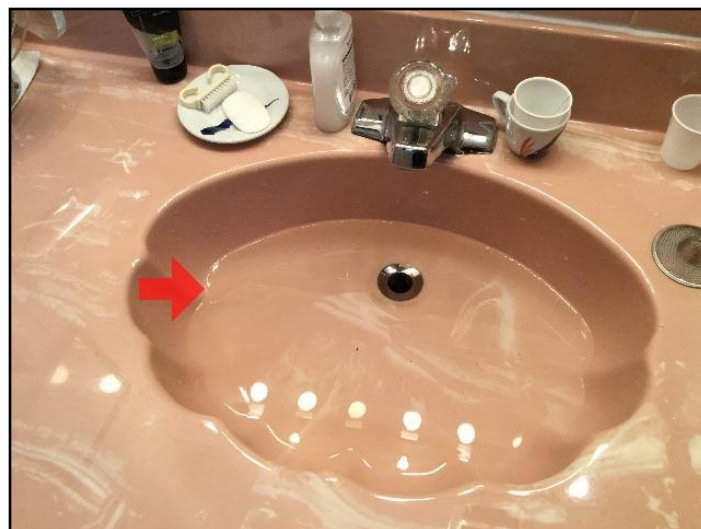
32. Condition: • [Slow drains](#)

Implication(s): Chance of water damage to contents, finishes and/or structure

Slow draining

Task: Correct / Improve

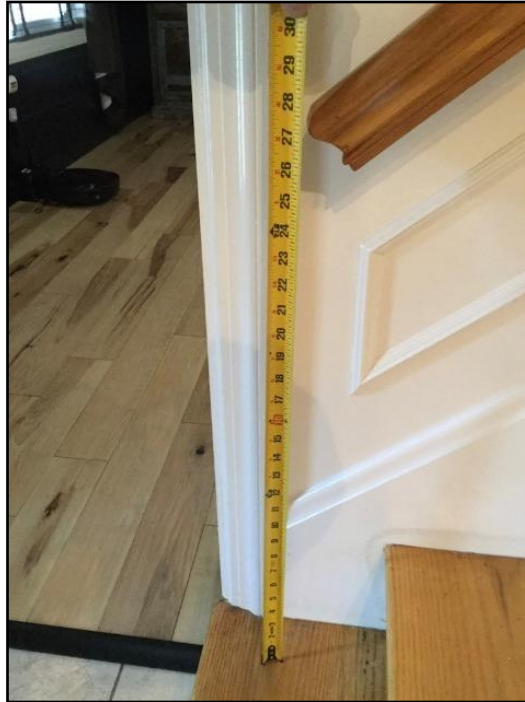
34. Condition: • [Too low](#)

Implication(s): Fall hazard

Handrail is too low

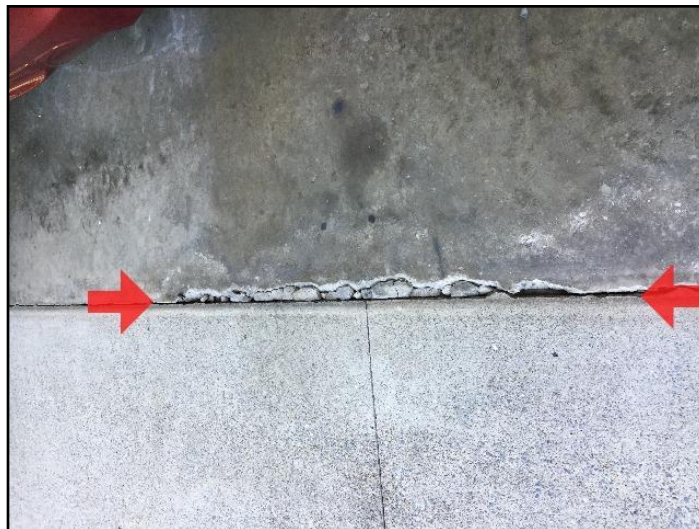
35. Condition: • [Cracked](#)

Cracked

Recommend repairing to help prevent further cracking / deterioration of garage floor.

Task: Monitor / Repair

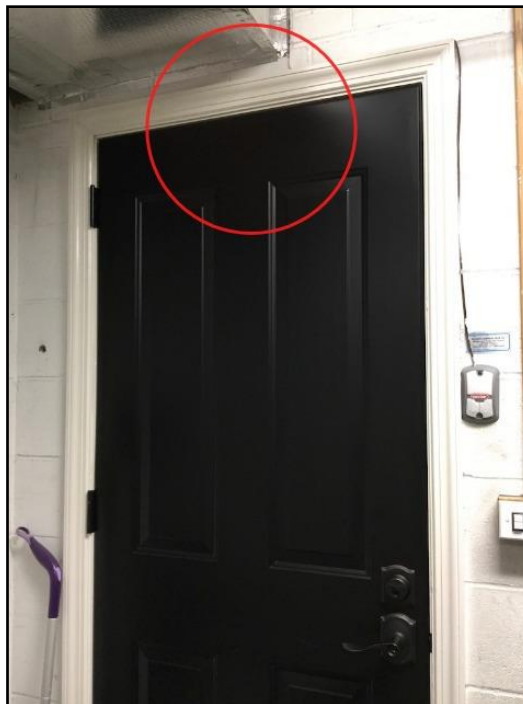
36. Condition: • Man door separating garage from home should have a 20 minute fire-rating (1 3/8" solid wood or steel) and should be self-closing. Recommend this improvement for fire safety and to prevent hazardous fumes from entering.

Missing self-closer

Task: Improve / Upgrade for safety

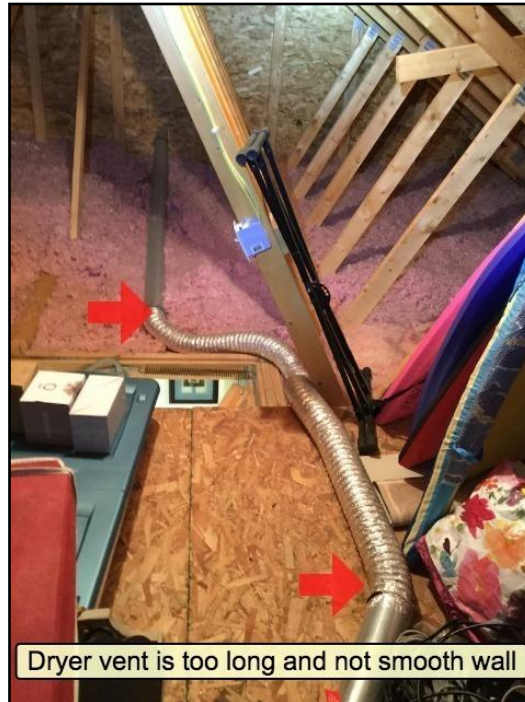
37. Condition: • Dryer vent material not smooth wall
Replace with smooth wall pipe to help prevent lint build-up.

Implication(s): Equipment ineffective | Fire hazard

Dryer-not smooth wall / excessive in length

Task: Correct / Improve for safety
